## White Paper

Eliminating  
**Unplanned  
Production Downtime**  
Instances Due to Replacement  
of M8 Proximity Sensors  
in Mig Welding Cell

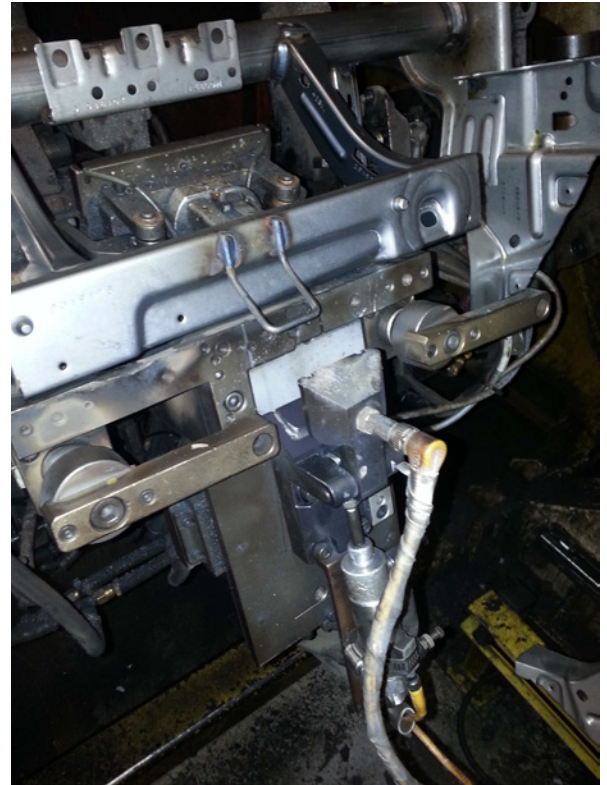
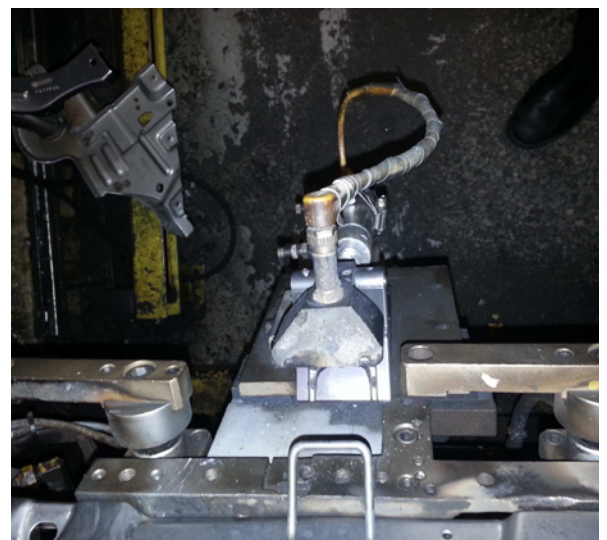
Discussions with Maintenance Management while observing the Cell in action revealed that most M8 sensors are being replaced in one application. The reason for sensor replacement in this high usage spot is impact with the finished part while the operator is unloading it.

It was also observed that M8 sensors had become loose in their mounting brackets. This is common when mounting nuts can only be used on one side of the bracket and can lead to exposure to further impact damage.

- 1) Work with Maintenance to create a simple protective cover to absorb any impact from the finished part while it is being removed.
- 2) Install Quick Tube mounting brackets to lock the sensors into place - ensuring that they do not become loose and exposed to further impact damage.

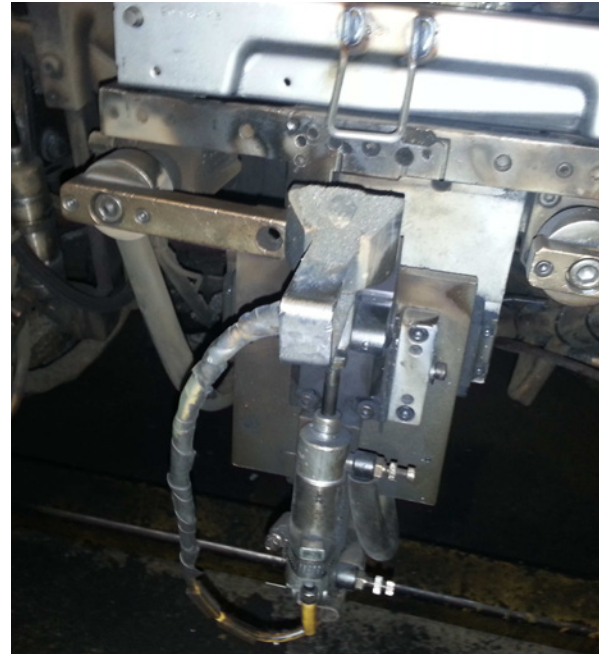
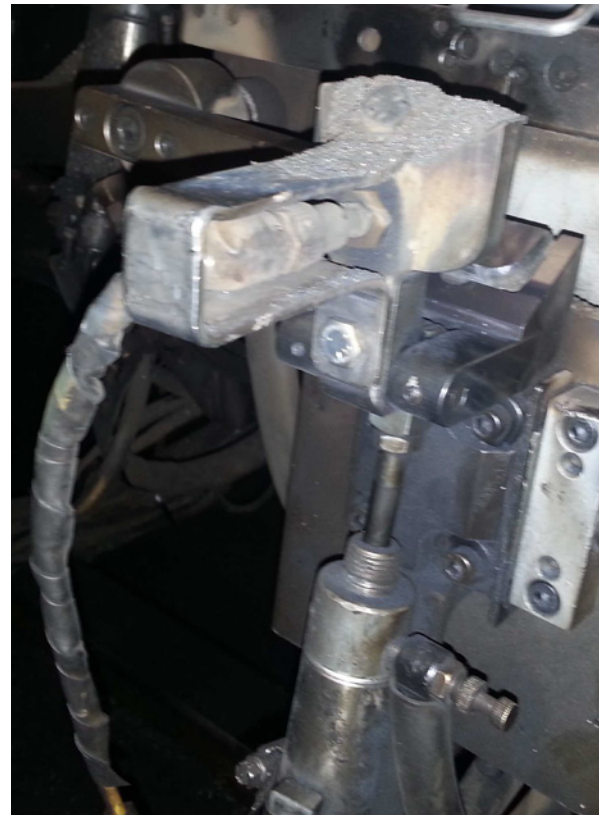
The manufacturer created sensor brackets designed to protect the sensors against impact when parts are being unloaded. The sensor brackets were installed the week of October 6<sup>th</sup>, 2014. The brackets have been effective at absorbing impact when the parts are unloaded as is evident in the impact damage on the brackets.
