## White Paper

Eliminating  
**Unplanned  
Production Downtime**  
Instances Due to Replacement  
of Sensors in Instrument Panel  
Beam Production Cell

HTM performed an audit on the IP Beam line to determine which strategy will best eliminate costs and downtime related to this sensor application.

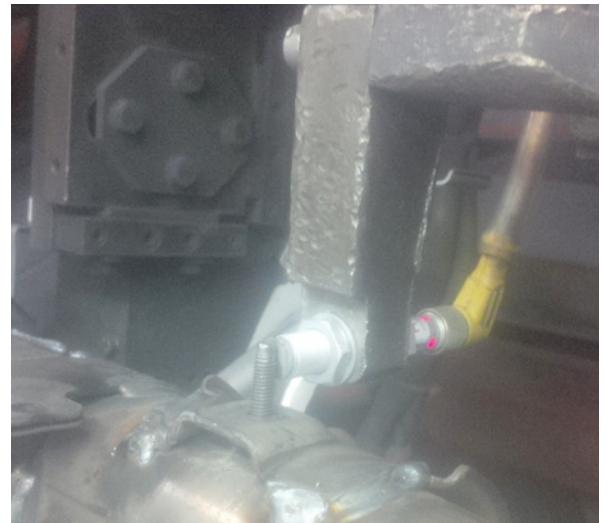
Discussions with maintenance experts while observing the IP Beam in action revealed that the majority of M12 sensors are being replaced in one application on the final station of the IP Beam line. The reason for sensor replacement in this high usage spot is impact with a stud on the finished part while the operator is loading it.

The current 4 mm range sensor was replaced with a MetalHead™ sensor with 6 mm sensing range. This will enable the sensor to be farther from the part it is detecting reducing the frequency of impact.

A sensor cap was installed to further protect the sensor face from any future impact.

The Maintenance Manager is having a bracket built to protect the underside of the sensor ensuring that the stud being detected will hit the bracket before hitting the sensor face.

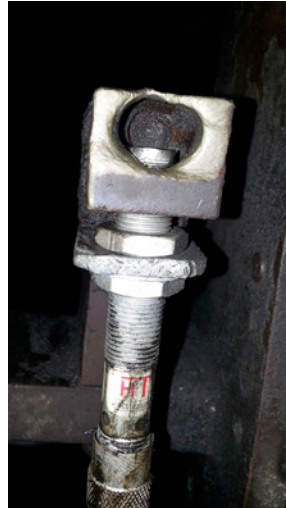
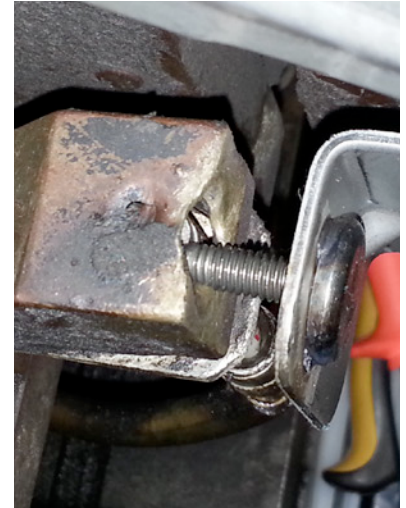
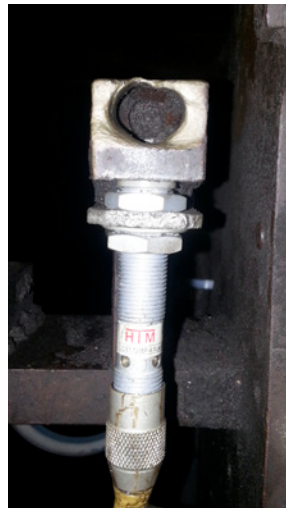
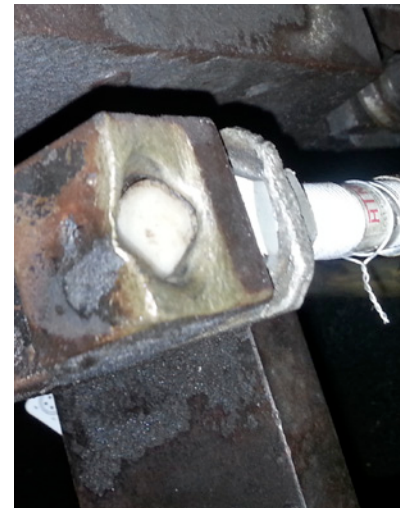
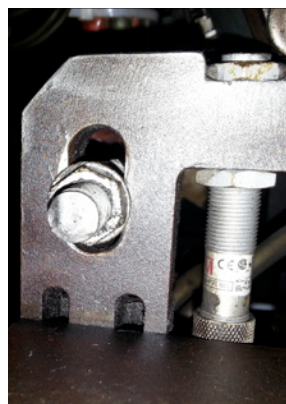
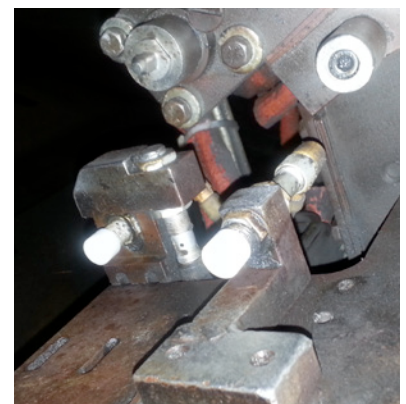
M12 Proximity Sensors are also being replaced in several application on the 2<sup>nd</sup> of the IP Beam line due to impact damage when the part is being loaded.

The head of the sensor is elevated above the opening lip and is thus exposed to impact from the stud as it is loaded. This repeated impact is leading to damage and eventual sensor failure.

A MetalHead<sup>TM</sup> Sensor with 6 mm range was implemented enabling the sensor to be mounted lower in the opening lip – partially shielding it from impact. A sensor cap was then installed to further protect the sensor face from any potential impact.

M12 sensor caps were also installed on exposed M12 sensors on the 2<sup>nd</sup> IP Beam Station.

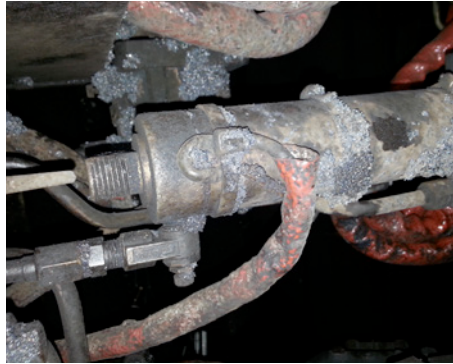
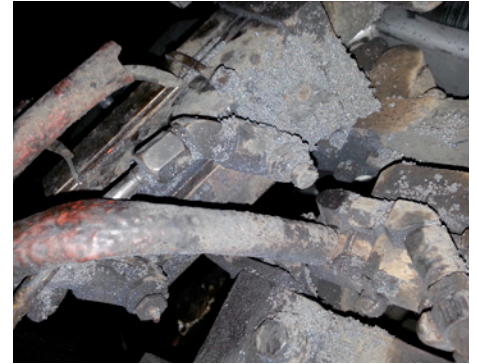
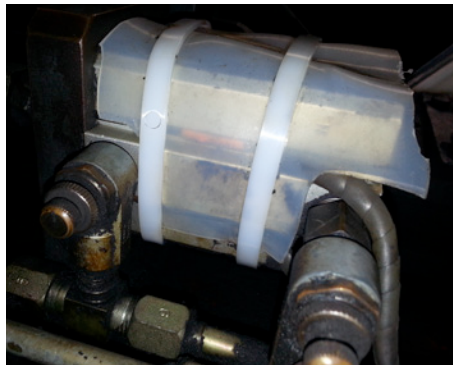
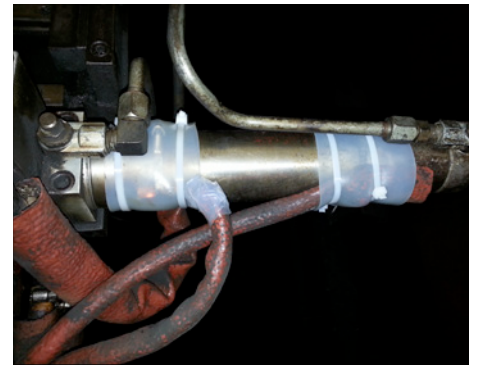
C-Slot Cylinder Sensors are being replaced very frequently due to heat and weld spatter damage. One specific sensor on the final IP Beam station is being replaced daily.

Silicone sheet was custom cut and wrapped around exposed cylinder sensors to protect them from heat and weld spatter damage. This technique has proven extremely effective at reducing cylinder sensor usage on other IP Beam lines.

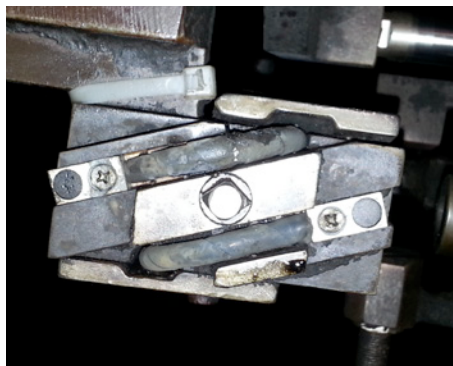
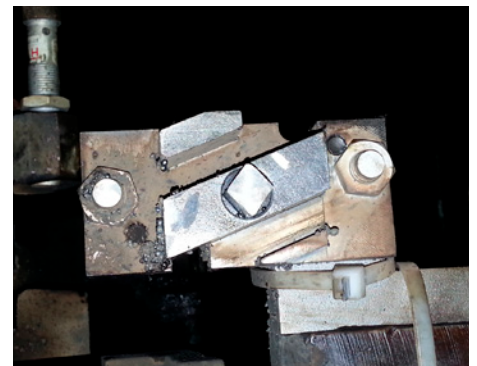
M8 rectangular sensors are being replaced frequently on the 1<sup>st</sup> station of the IP Beam line in 4 specific brackets. They are being replaced due to heat, weld spatter, and impact/abrasion damage to the pig-tail cable.

The Maintenance Manager has had a new mounting block created that will eliminate these rectangular sensors, using M8 cylindrical sensors instead. This enables the sensors to be better protected from impact and heat as well as eliminate the issues with cable damage due to impact.
