## White Paper

Eliminating  
**Unplanned  
Production Downtime**  
Instances Due to Replacement  
of Cylinder Sensors  
in Mig Welding Cell

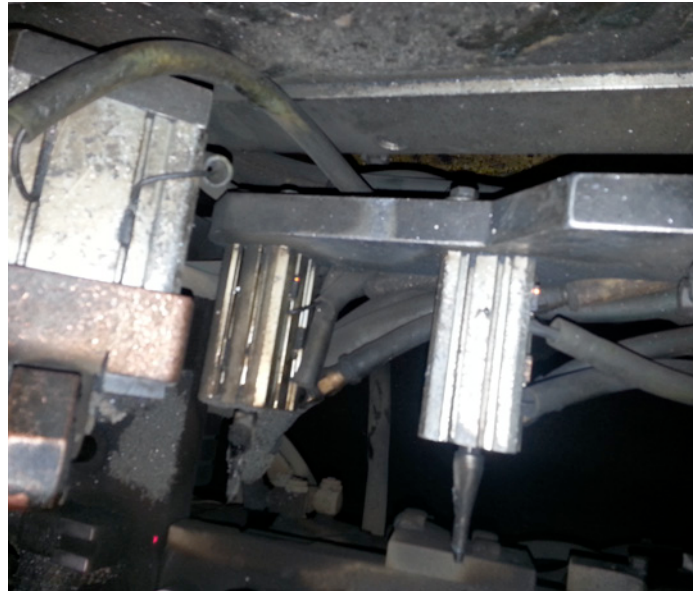
Discussions with Maintenance while observing Cell 371 in action revealed that most cylinder sensors are being replaced in 3 applications. The reason for sensor replacement in these high usage spots is damage due to weld spatter.

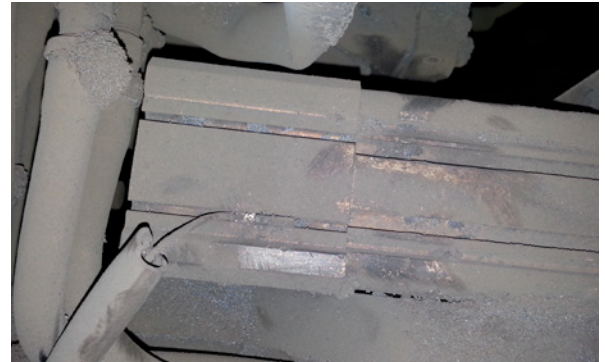
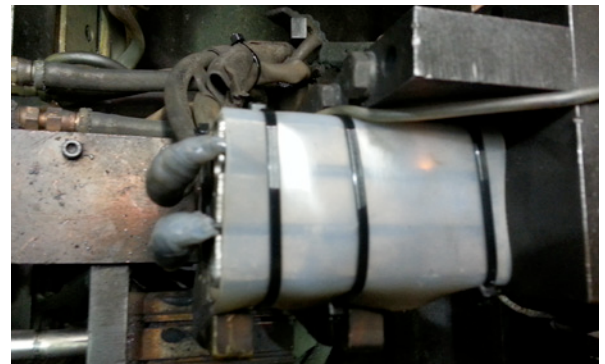
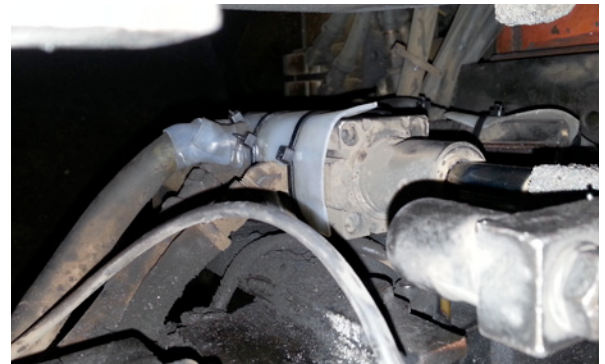
HTM identified 22 cylinders on Cell 371 that used C-Slot cylinder sensors for position detection. Each of these cylinders was exposed to heat and weld spatter build up.

Each of these cylinders was wrapped in custom cut silicone sheeting and firmly fastened with tie wraps. The silicone sheeting protects the cylinder sensor from weld spatter damage while ensuring that LEDs are still visible for easy troubleshooting.

To protect the cylinder sensor cable that was not covered by the silicone sheet, silicone tape was administered. Silicone tape has proven to be effective at reducing damage to sensor cables and pig-tail connectors due to weld spatter burns.
